Debris Flow Capture Investigation of Steel Open-type Sabo Dams around Mt. Aso, JAPAN

Hiroshi MORIYAMA¹, Hiroshi KOKURYO¹, Masakatsu YAMAGUCHI¹,
Ryuta INOUE¹, Nobutaka ISHIKAWA¹, Joji SHIMA²

Key words: steel open-type Sabo dam, debris flow, capture investigation, woody debris, Mt. Aso

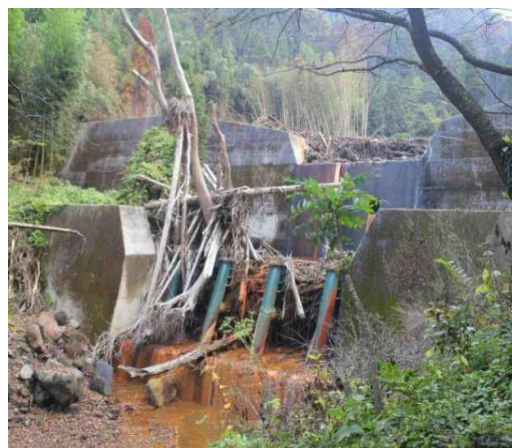
The Shioi river dam, which is a steel open-type Sabo dam with 3 m height, was established as the secondary dam of a concrete closed-type dam. The main dam was completely filled with sediments, with boulders exceeding 3 m in diameter present at a few locations. The secondary dam was also filled with a large amount of woody debris and sediment, as shown in **Photos 1** and **2**.

Photo 1 Capture of sediment and woody debris (Shioi river dam)

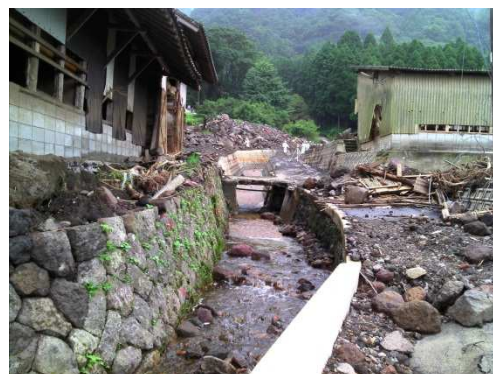
However, owing to the large amount of sedimentation, sediment discharge to the downstream area occurred from the top edge of the steel dam, as well as from the service road on the left bank. Unfortunately, this resulted in damage caused by sediments downstream, but we presume

Photo 2 The situation of down stream (Shioi river dam)

that the facility reduced the damage to the downstream areas.

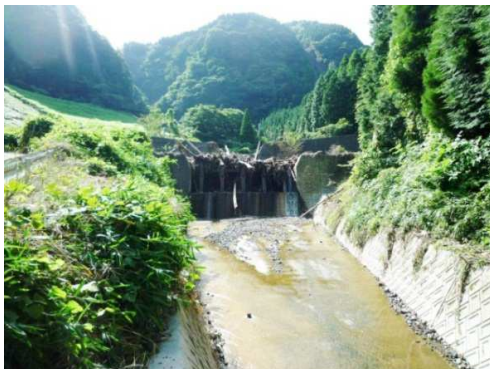
An investigation was conducted on three steel open-type Sabo dams located on the Hebonoki river, at Koga Fall, and on the Yoroizuka river. At the Hebonoki river, a steel open-type Sabo dam composed of a steel structure with 3 m height was established as the secondary dam. Woody debris that overflowed the main dam was captured by this steel open-type Sabo dam, as shown in **Photos 3** and **4**.

No discharge of sediment or woody debris downstream was confirmed, and this dam, together with the main dam, is considered to have demonstrated significant effectiveness.

Photo 3 Capture of sediment and woody debris (Hebonoki river dam)

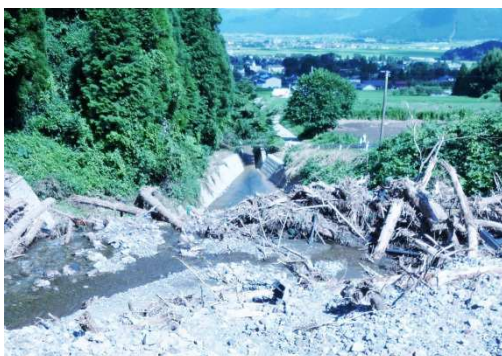
Photo 4 Capture of sediment and woody debris (Hebonoki river dam)

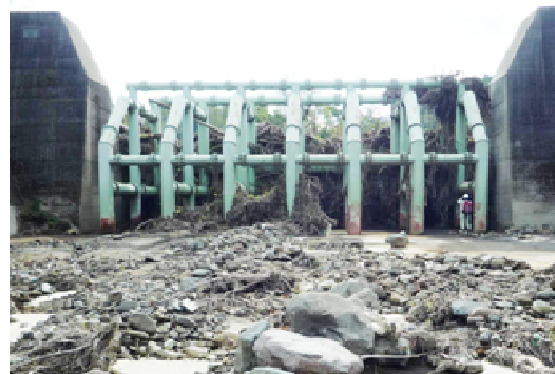
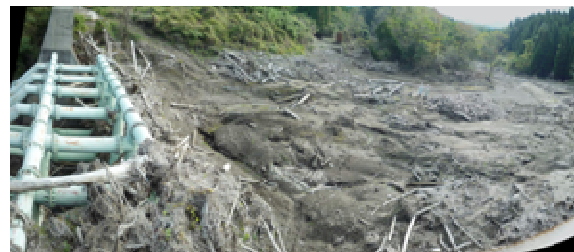
Photo 5 Capture of sediment and woody debris (Furue river No.9 dam)

main dams(**Table 1**). From downstream to upstream, these are known as the Furue river No. 9, Furue river No. 2 (8m high steel structures in both cases), and Furue river No. 11 dams (4.5m height). The three dams were almost fully heaped up, with their openings blocked by woody debris and shrubs accompanied by sediment comprising primarily fine sand that was captured almost up to the top (refer to **Photos 5** and **6**). Damage resulting from sediment floods involving woody debris that reached the vicinity of National Road No. 57 occurred during the disaster of 1990, but no floods occurred downstream by the effects of these dams at this time(refer to **Fig. 2**).

(a) The situation of open part

(b) The situation of upper stream

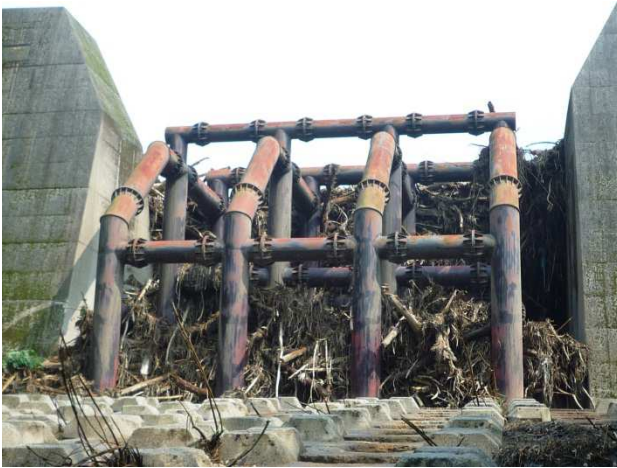
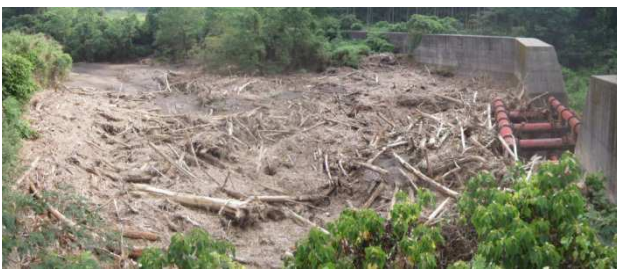
Photo 6 Capture of sediment and woody debris
(Frue river No.2 dam)

(a) The situation of open part

(b) The situation of upper stream

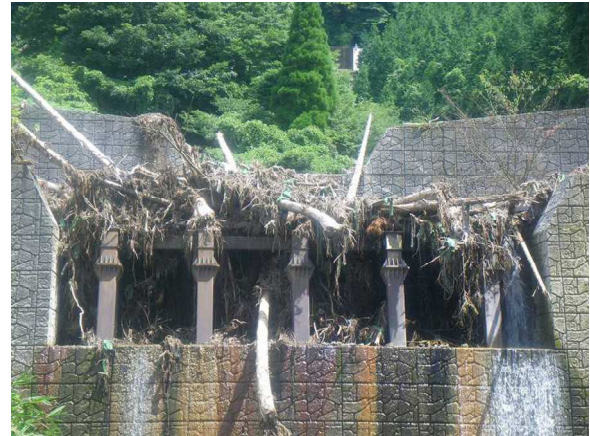
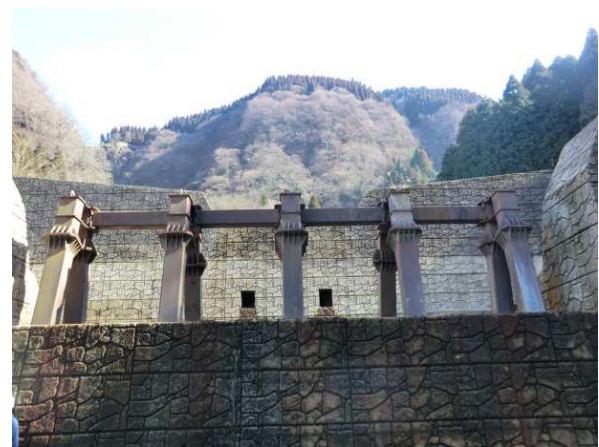
Photo 7 The situation of woody debris removal
(Hebonoki river dam)

3. INVESTIGATION OF SOUNDNESS

(a) Before woody debris removal

(b) After woody debris removal

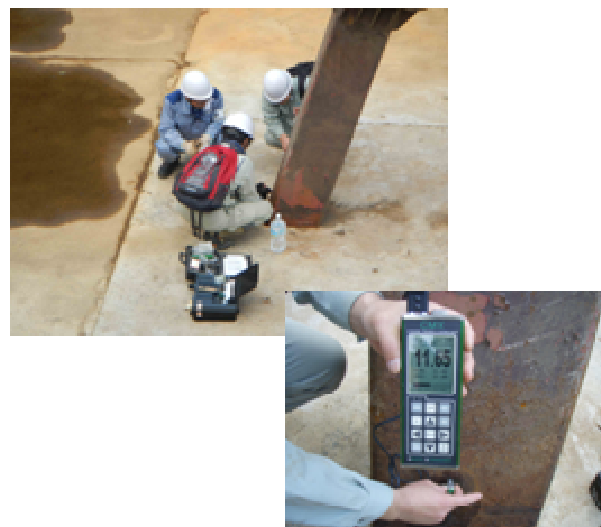
Photo 8 Investigation of soundness

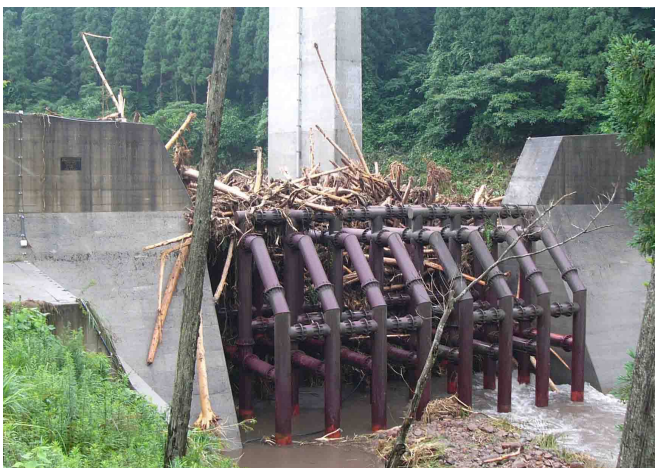
Photo 9 shows a case where a large amount of woody debris was captured by an steel open-type Sabo dam. A number of closed-type dams are

Photo 9 Capture of woody debris (Kitazato river dam)

installed upstream from this dam, and they capture gravel and sediment, but they fail to capture almost all woody debris, and thus it is captured by this downstream open-type steel Sabo dam.

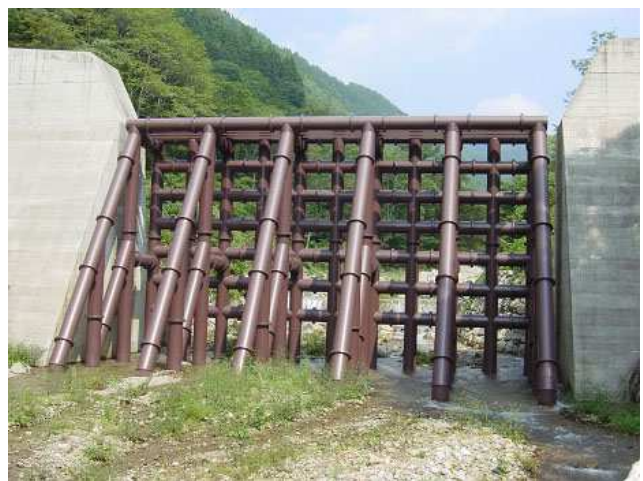
Photo 10 illustrates a picture of an open-type steel Sabo dam taken from the downstream side a few years after it was completed. This dam was designed prior to the recent manual revision, but because it is the dam furthest downstream, the steel pipe spacing was set to 1.0 times the maximum gravel size. It is confirmed from the photograph that an upstream side entrapment function can be maintained even with a dam which improves capture functionality in this way.

Photo 10 Maintenance of entrapment function (Suganumadani dam)

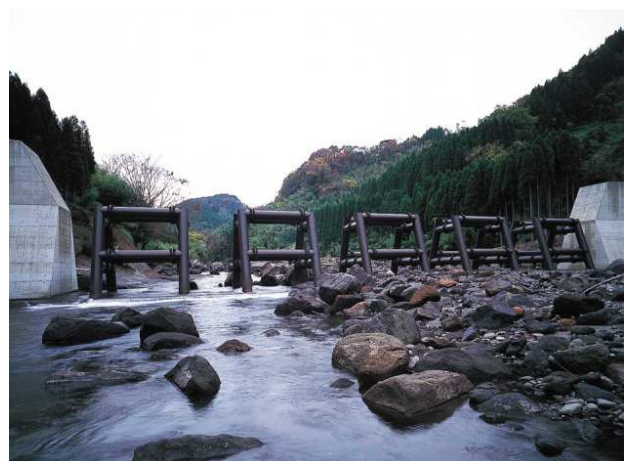
Photo 11 Conservation of mountain stream environment (Sanbonmatsu dam)

Photo 11 shows a case where a steel open-type Sabo dam has been installed. The foundation of the steel open-type Sabo dam is installed in line with

the current river bed. Therefore, aquatic creatures can freely come and go, and effects on the ecosystem are minimized. Cases have also been reported where deep and shallow areas are naturally formed upstream from a dam where there have been no debris flows for a few years, and fish are living there.
