Debris Flow Capture Investigation of Steel Open-type Sabo Dams around Mt. Aso, JAPAN

Hiroshi MORIYAMA¹, Hiroshi KOKURYO¹, Masakatsu YAMAGUCHI¹,
Ryuta INOUE¹, Nobutaka ISHIKAWA¹, Joji SHIMA²

Key words: steel open-type Sabo dam, debris flow, capture investigation, woody debris, Mt. Aso

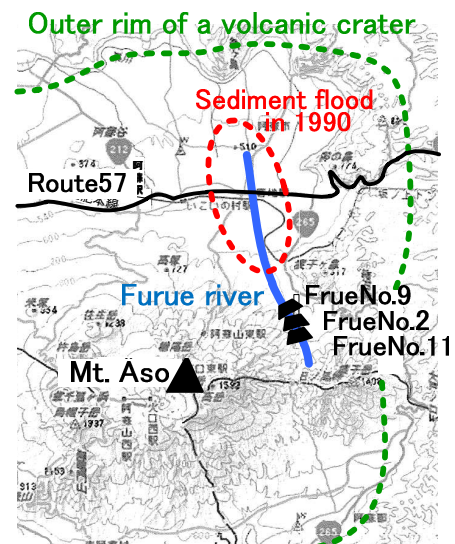
Fig. 2 Map of drainage area of Furue river

main dams(**Table 1**). From downstream to upstream, these are known as the Furue river No. 9, Furue river No. 2 (8m high steel structures in both cases), and Furue river No. 11 dams (4.5m height). The three dams were almost fully heaped up, with their openings blocked by woody debris and shrubs accompanied by sediment comprising primarily fine sand that was captured almost up to the top (refer to **Photos 5** and **6**). Damage resulting from sediment floods involving woody debris that reached the vicinity of National Road No. 57 occurred during the disaster of 1990, but no floods occurred downstream by the effects of these dams at this time(refer to **Fig. 2**).
